UNITY 600 upgrade to UNITY600 Plus:

Lock signal problem:

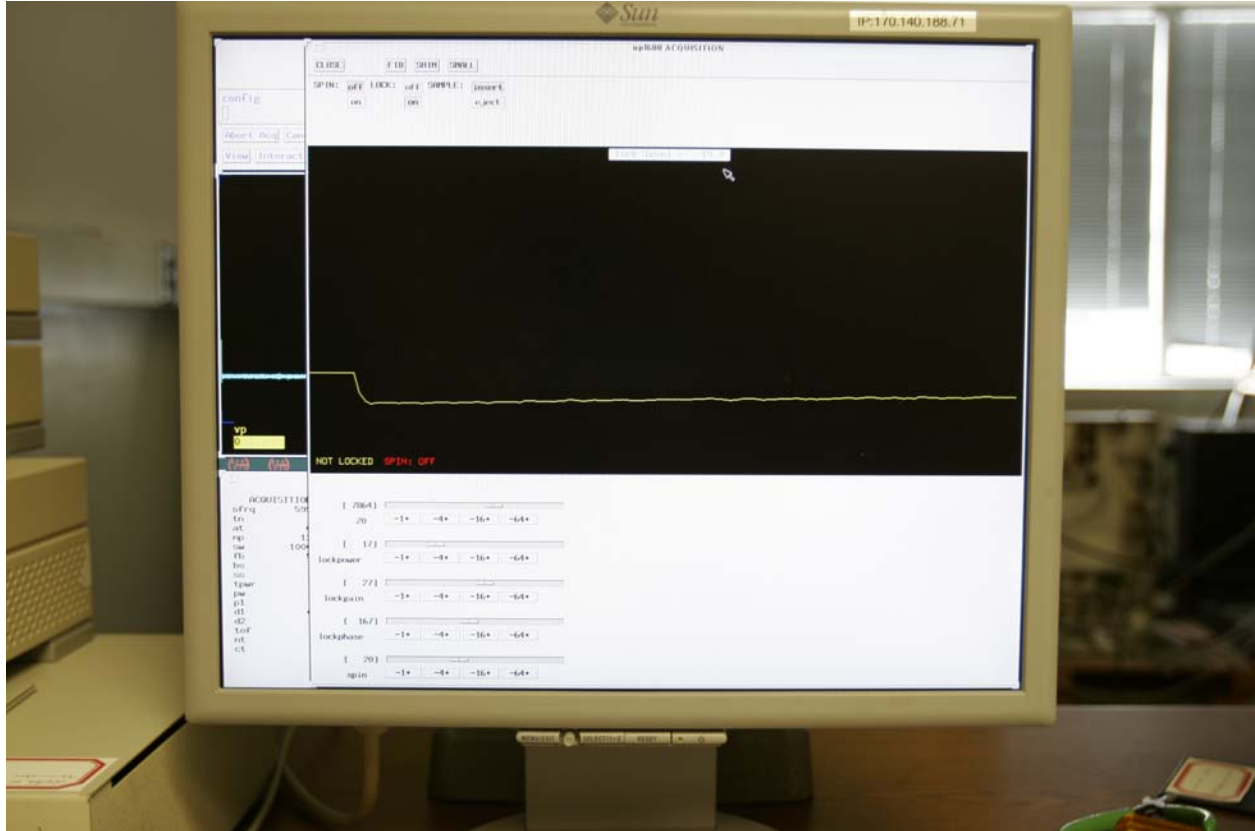
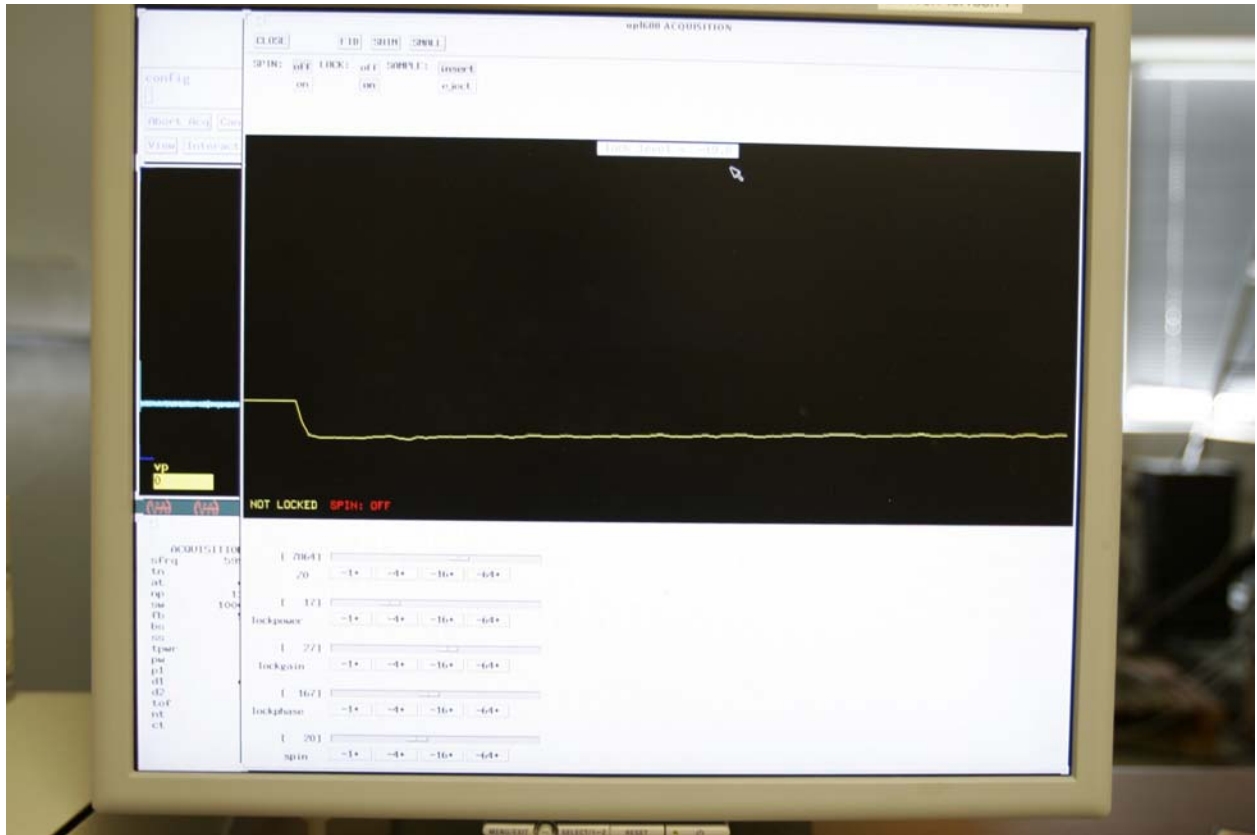
It could be locked, but the signal is 180 degree difference.

It is required to reset the polarity switch on one of the shim board:

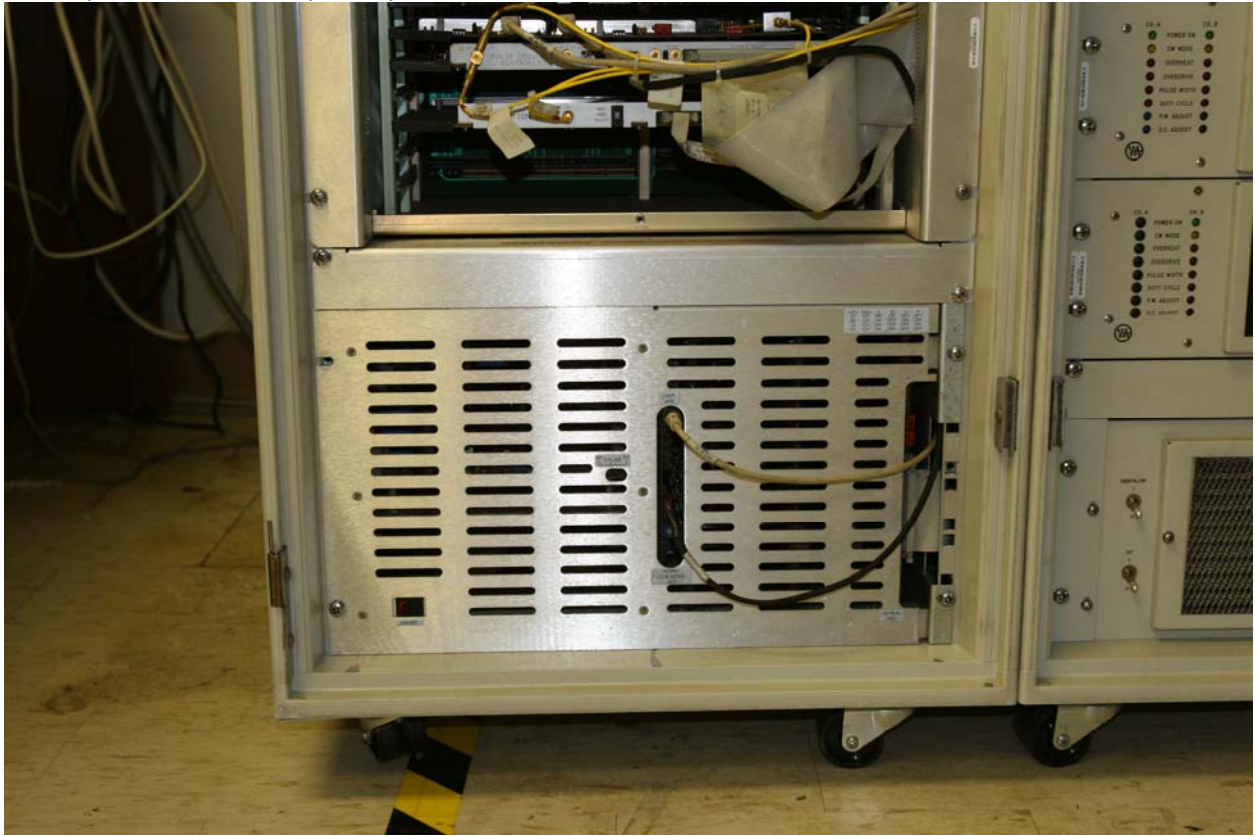
Shim power supply unit on the unity plus console.

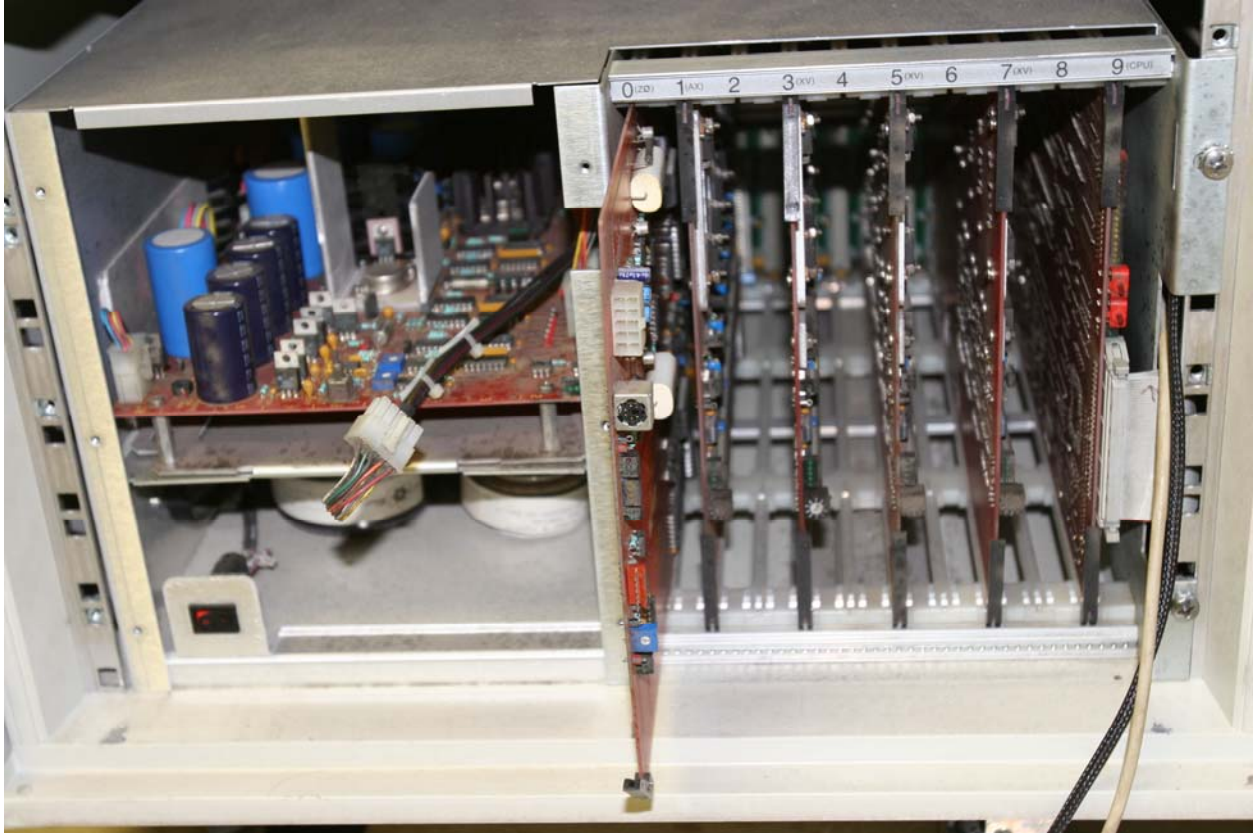
The sw1 is the polarity switch. After flip it, and reinstall the board. Power on the console.

The lock signal should be reversed.
